Survey No. SM-372

## Maryland Historical Trust State Historic Sites Inventory Form

1. Nam	e (indicate pre	eferred name)		
historic	MATTINGLY HOU	SE		
and/or common				
2. Loca	ation			
street & number	E, Side Old R		north of Charlot hool Road	te _ not for publication
city, town	Charlotte Hal	1 vicinity of	congressional district	
state	Maryland	county	St. Mary's

Mattingly House

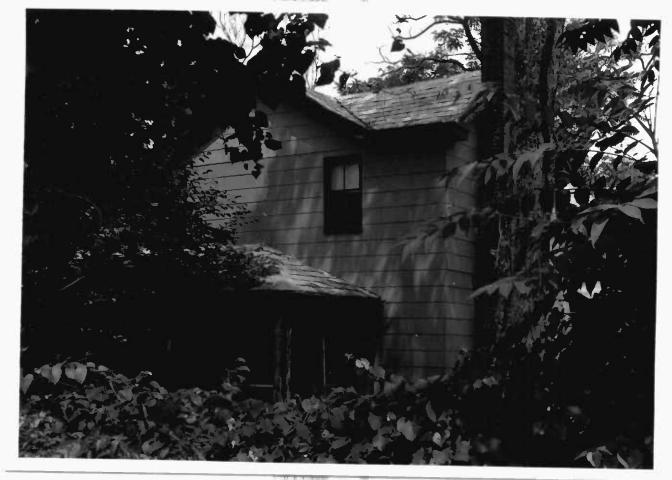
W. Facade

The Mattingly House is a two story, four bay wide gable-roofed house with a double cross gable on the west or entrance facade. A wide one story hipped-roof screened porch extends across the west facade, with entrances on the west, north and south sides.

The entrance doors, one below each of the cross gables, are made of beaded flush paneling. The windows on the north, west, and south facades are mostly 2/2 double hung windows. A six bay wide two bay deep shed roofed wing and an adjoining one story two bay gable roofed wing extend from the east elevation. This section is probably much later than the main block and the windows are mostly paired or triple 6/6 sash. There is a small one story shed-roofed addition on the northeast corner of the house with an entrance on the east facade.
